# Town of Newbold Facilities Analysis Study Report

## Town of Newbold – Building Committee Town of Newbold, Wisconsin

11/05/19 Draft, 11/06/19 Revised,  
7/14/20 Final

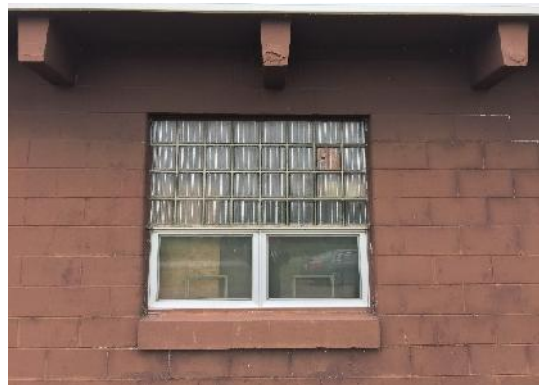
J

The roof is assumed to be adequate as the shingle are newer and appear to be in good shape. During our visit it was noted that the roof has additional batt insulation added, exact amount is unknown. The gable end siding is in poor condition. (Photo G, H, I) The prestressed joist extending beyond the exterior wall are delaminating due to freezing and thawing conditions of the exterior environment. (Photo J)

Exterior service doors are in poor shape, the frames are rusted through. (Photo K, J, L, M) Overhead doors are insulated with vision glass and motorized openers are in good condition, the exterior weather stripping has failed. (Photo N) Slab at the overhead doors has areas of edge spalling, where the overhead door has no sealing capabilities to the slab. (Photo O). Window units are inset into glass block with single glazed operable units. (Photo P, Q) Many openings have been blocked by furnishings allowing for no access. The units are in poor to failed condition. Interior wood doors are in fair condition.

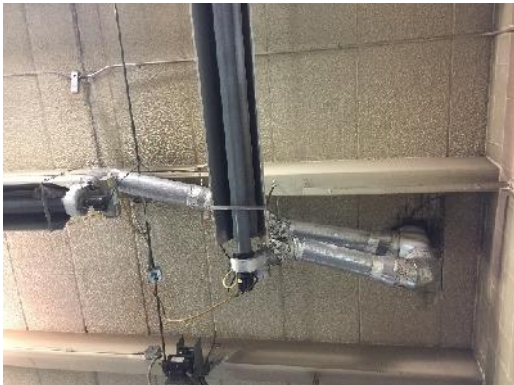
R

Interior ceiling exposed lightweight perlite slab material is in good condition except for the shop area around the radiant heater exhaust pipe. (Photo R)

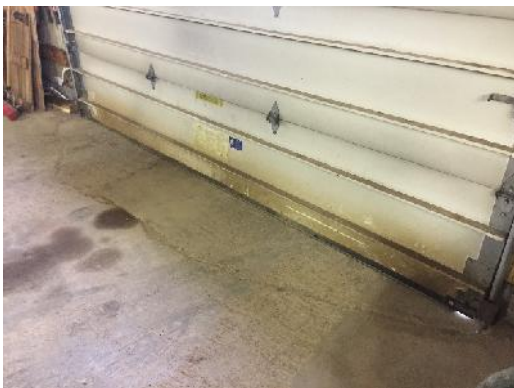
T

The building is in poor condition. The structure is assumed to be sound; areas of structural concern include the foundation/slab crack at the interior of the overhead door, the crack runs west the entire length of the overhead door approximately 3' into the room. The perimeter block curb does not appear to be anchored to the foundation with portions removed at some point in time to allow water to run out of the building that has collected on the interior concrete slab. (Photo T) The interior slab has no slope or interior floor drainage.

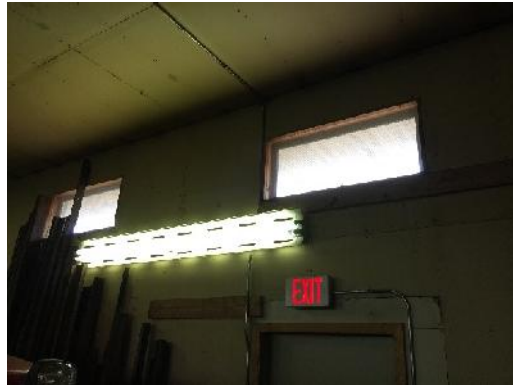
W

The exterior service door is in poor shape and inoperable at the time of the visit. It appears that the door frame is binding up within the exterior wall not allowing the door to freely operated. Overhead door is insulated with vision glass and motorized opener. The track has a tight radius for lifting due the wall height causing the door to jerk and bind as it is operated, the door is in good condition. (Photo V) Window units are in fair condition. (Photo W) Interior ceiling is exposed gypsum board that was

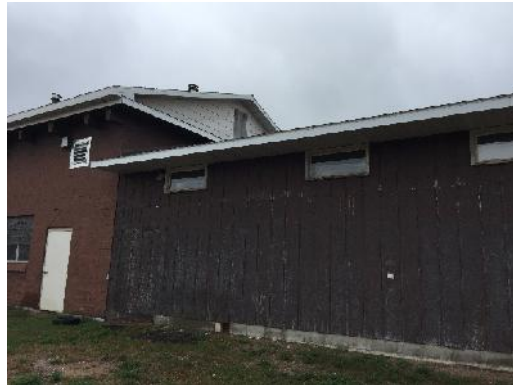
Y

Exterior wall is exposed gypsum wall board that was never finished. There have been many areas repaired due to failure, most likely damaged by equipment stored along the exterior walls. (Photo X) The exterior wall wood panels have failing at the bottom of the panels adjacent to the concrete sill block curb due to moisture. The exterior wood panels and trim are in poor condition. (Photo U, Y, Z)

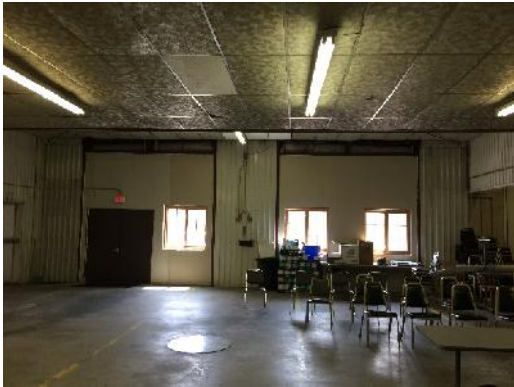
A

The interior suspended ceilings are all in poor to failed condition. (Photo A-D) The existing ceramic tile and vinyl flooring is in fair condition. Some cracking and peeling of the vinyl floor were noted.

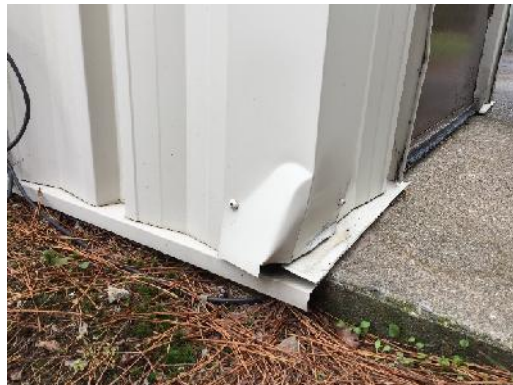
I

The front exterior wall facade is subject to expansion and contraction, it is assumed that the furring method was attached to the existing horizontal wall girts, making it difficult to control. There are numerous areas of damage to the gypsum wall panel that have been repaired. Most of the sealant joints have failed at the material transitions. (Photo F, G, H) The remaining metal wall panels are in good condition, the corner cover trim is not sealed well allowing vermin to enter the facility. (Photo I)

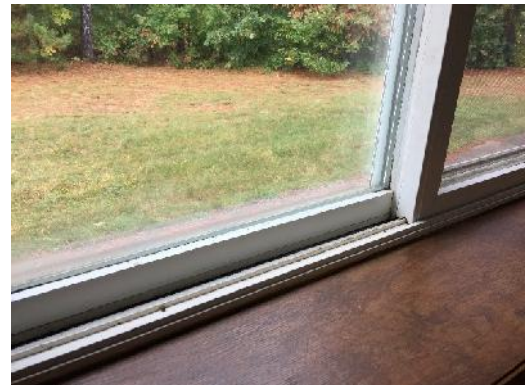
J

Exterior service doors are in good shape. Vinyl windows show wear and gasket shrinkage, they are in fair condition. (Photo J) Exterior clad wood windows are in good condition. (Photo K).

**Openings:** Replace vinyl windows with exterior aluminum clad wood slide by windows. Reseal all exterior joints at perimeter of windows and doors. Replace all material transition sealant joints, repair any exterior gypsum wall panels and repaint. Repaint hollow metal door frames. Replace all non-compliant hardware.

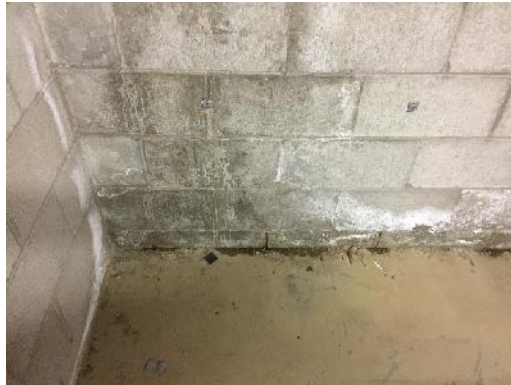
L

The existing foundation is structurally sound however there are signs of moisture penetration through the block foundation wall. The wall is deteriorating through the means of freeze thaw cycles causing the wall to blister and crumble. (Photo L)

Excavate an area around the existing basement foundation wall on the three exterior walls exposing the existing block wall. Clean wall and prep for the new waterproofing, install new exterior foundation insulation with exterior drainage membrane along the outside of the insulation. Install new sidewalk.

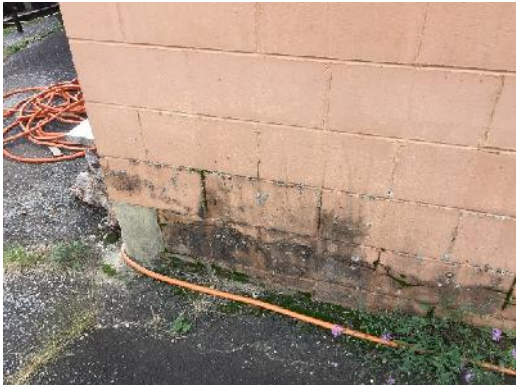
A

The building is in good to fair condition and structurally sound with minor exterior wall cracks and water infiltration. (Photo A, B) The current structural roof system appears adequate. The current IBC 2015 Snow Load is 42 psf plus dead load, (borderline OK), the IBC code is not retroactive, and as such, the roof is considered fully functional and compliant with current code. No damage was observed in the roof that would indicate historical over loading or a current hazard to occupants, so it can be left "as is". (Photo C, D) The gymnasium exposed glulam beams on the exterior are deteriorating due to the exterior environment, the exterior sections of the beams are in poor condition. (Photo E, F)

**External Walls:** Tuck point all exterior and interior cracked walls, cut new control joint in the first two west classrooms, remove all wood window boxes and repair any damaged brick. Reseal all control joints and material transitions with new sealants. Clean the existing brick to be free of mold. Install new weep holes in the existing exterior walls.

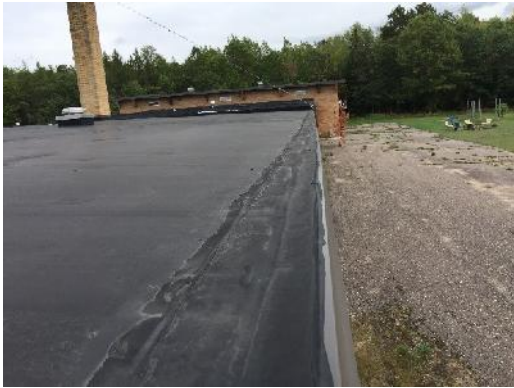
G

The roof membrane is in fair-poor condition, the owner noted that he patches the roof when leaks appear. Based on the exterior fascia trim the roof has additional rigid insulation added, exact amount is unknown. The roof should have core samples taken to determine the exact roofing materials and insulation depth. (Photo G, H, J)

**Roof:** Replace the existing roof, insulation and fascia. Repair all wood soffits. Review all flashings for any potential installation issues. Cut back the exposed rotted glulam beams at the gymnasium and clad the exposed glulams.

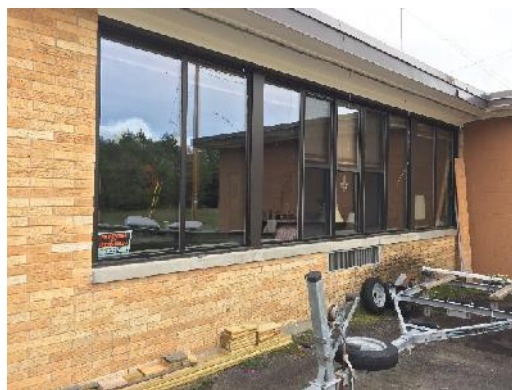
M

Exterior service doors are in good shape. (Photo K) Window units are in good condition. (Photo L, M)

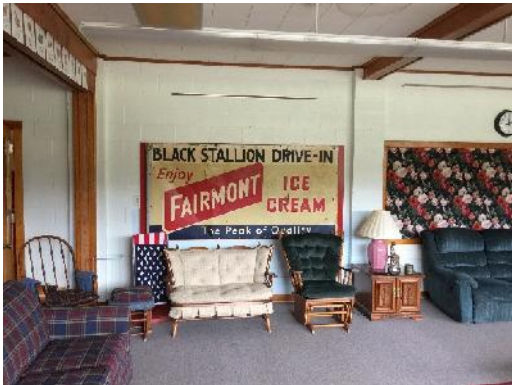
Q

Interior 12x12 glue applied tiles are in fair condition, the tiles are stained from roof leaks and show signs of sagging. (Photo Q, R) All interior carpet and vinyl tile is in poor condition. The vinyl tile and mastic (defined asbestos material) must be abated prior to any construction. (Photo S, T) Ceramic tile floor is in fair condition. Ceramic wall tile is in poor condition due to the alterations from the original design into a private residence. Wood doors, frames and trim are in fair condition, with scratches and veneer delamination. (Photo U, W, V) All interior concrete block walls are in good condition. Interior toilet room partitions are in poor condition as should be reconfigured. (Photo X-AA)

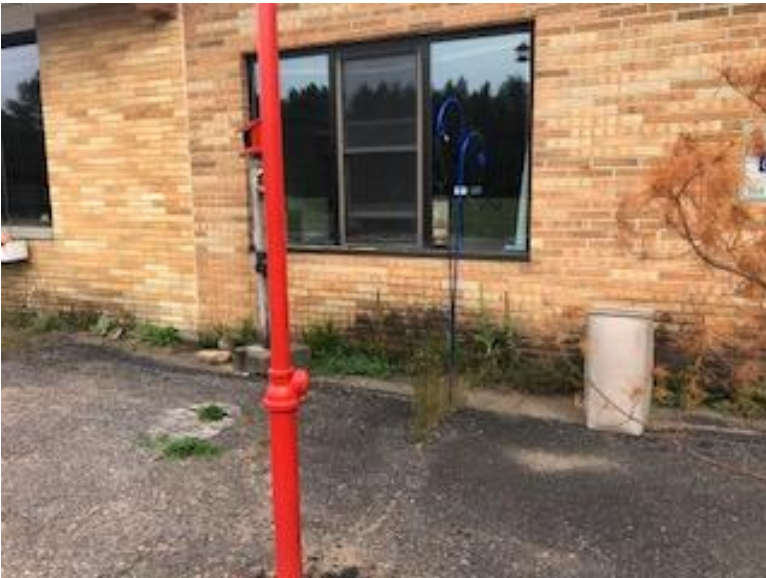
Several areas on the exterior are stained black by mold. This is not a structural problem but indicates water/moisture being trapped in the air space of the brick, unable to get out. Water may be entering the wall at the roof soffit, or window flashing, allowing water or condensation to remain inside the wall. There was no mold viewed on the interior, so the interior block backup appears to be intact. (no water infiltration into block). Although out of scope (structurally) this may be remedied by drilling weep holes at the bottom of the wall to allow water drainage out of the wall, and then sandblasting to clean the wall.

Typical staining at base of wall

- 1) Install weep holes at base of brick walls at “stain points” to provide internal drainage.
- 2) Seal windows/soffits at wall to prevent water entry into walls.
- 3) Investigate size of “3x12” beams at front of building to confirm capacity

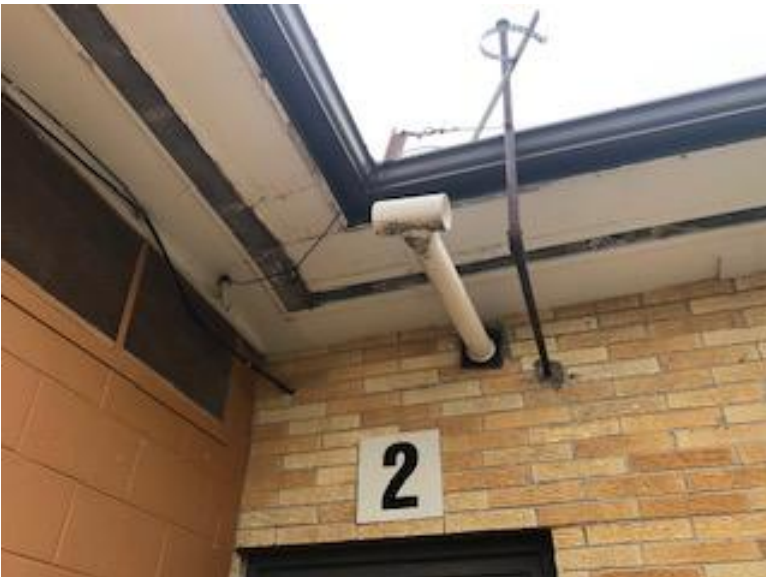
Soffit repair

In addition, window and soffit flashing above the staining should be inspected for openings that allow water to enter the wall. These entry points should be sealed.

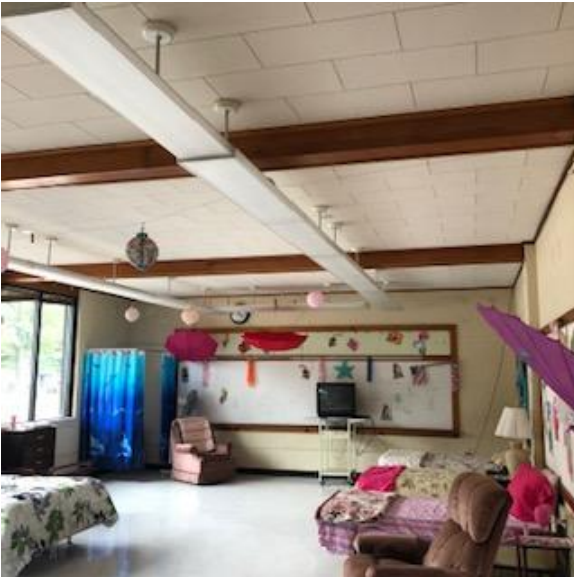
Covered beams at front of building

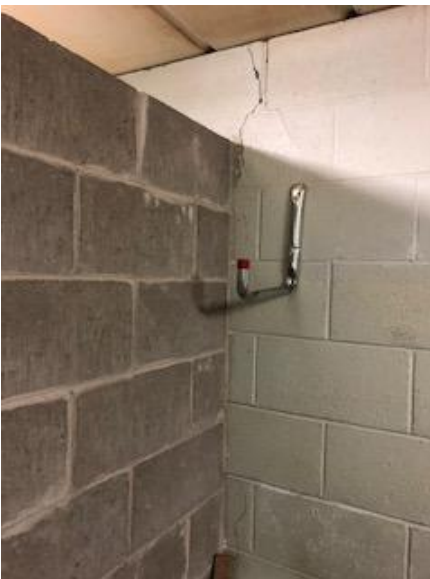
Minor cracking of the masonry was observed in the boys locker room. This cracking is considered non-structural and incidental to a “newer” wall placed perpendicular to the existing wall. No other cracking in the building was observed. Tuckpointing the masonry will remedy this issue.

Cracking in boys locker room
