# MICROBIAL INSPECTION

## Town of Newbold

4608 Apperson Drive  
Rhineland, WI 54501

NorthStar No. 210-994

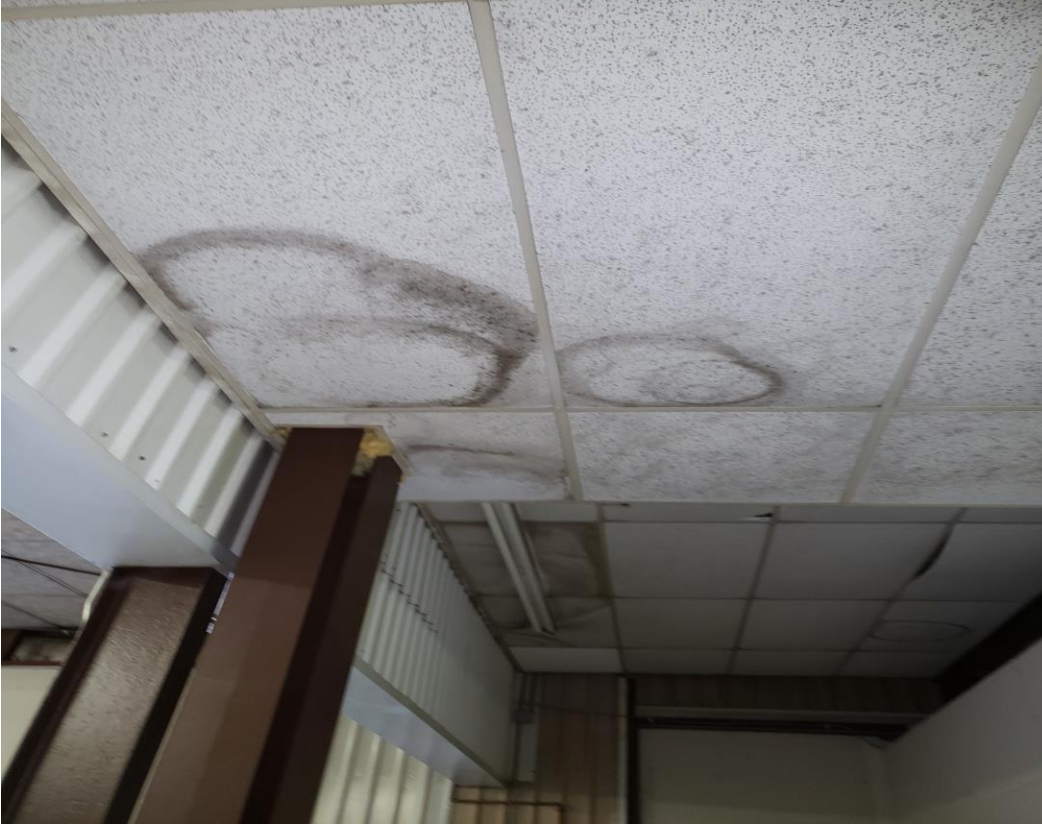
Photo 1: Location: Shop Area – Ceiling  
Item: Water damage on ceiling tiles from roof leak.

- All affected ceiling tile and insulation in areas of the ceiling that show visible water damage should be removed. Consider further investigation above the suspended ceilings for water damage, microbial growth or rodent damage and remove the affected materials accordingly. If signs of water damage are near an adjoining wall, consider further investigation into the wall cavity for additional damages.

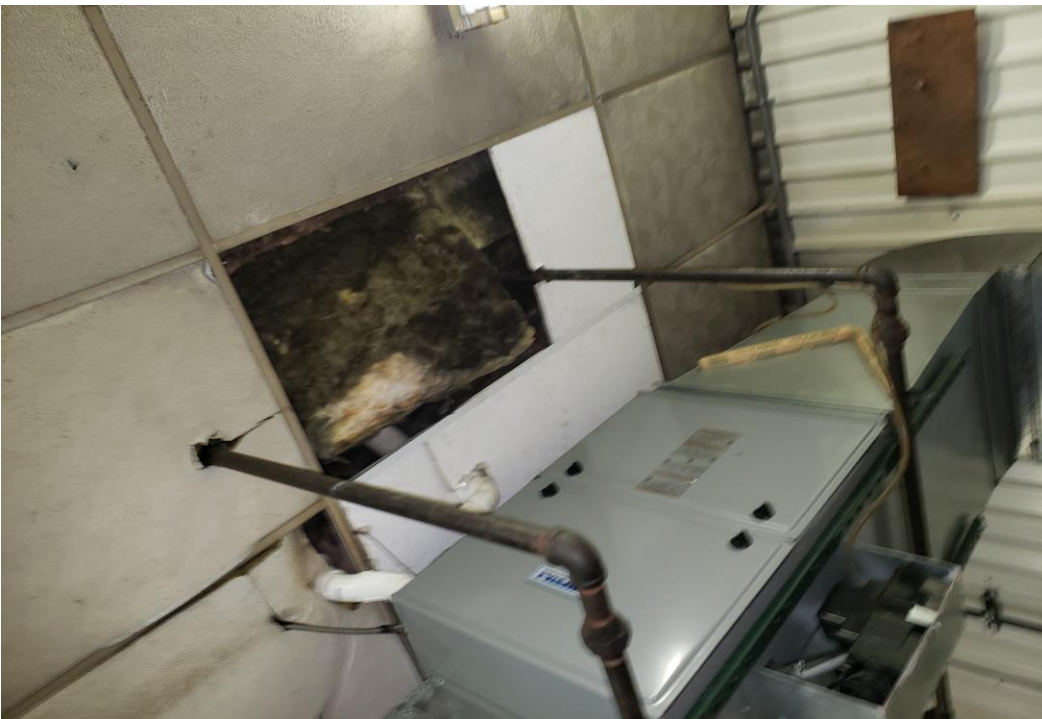
Photo 2: Location: Shop Area – Ceiling  
Item: Exhaust leak in furnace darkening the insulation.

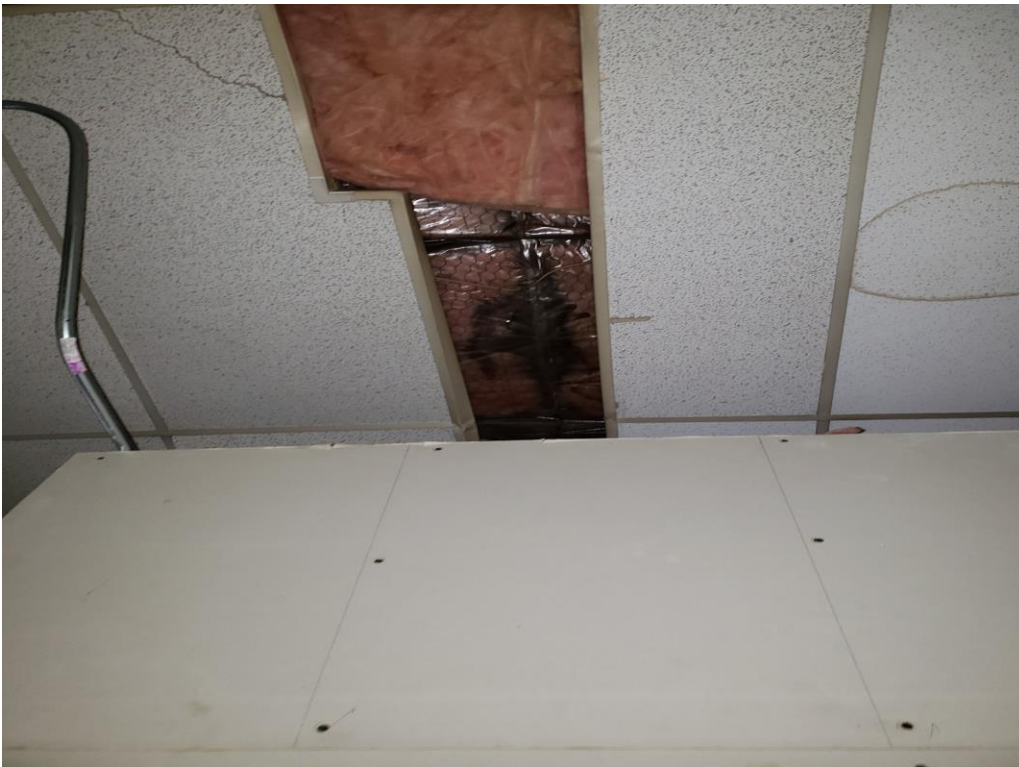
Photo 3: Location: Shop Area – Ceiling  
Item: Water damage on insulation above ceiling tile.

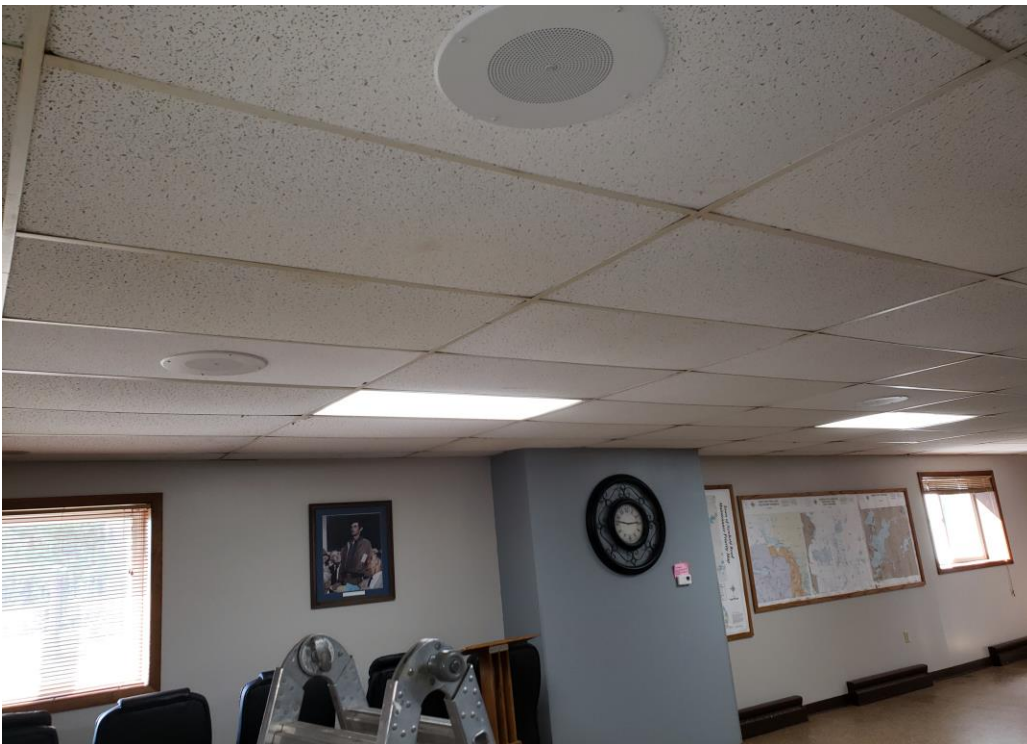
Photo 4: Main Level – Meeting Room Area  
Item: Overall View – Ceiling tiles sagging possibly due to previous humidity issues.

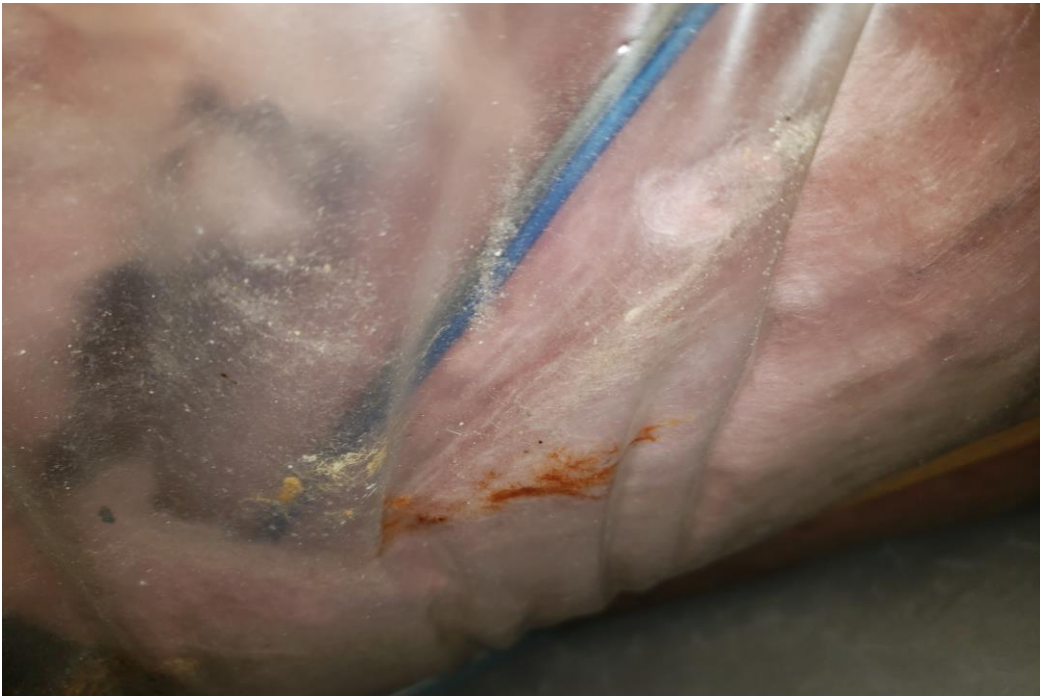
Photo 5: Main Level – Meeting Room Area  
Item: Water damage on insulation above ceiling tile.

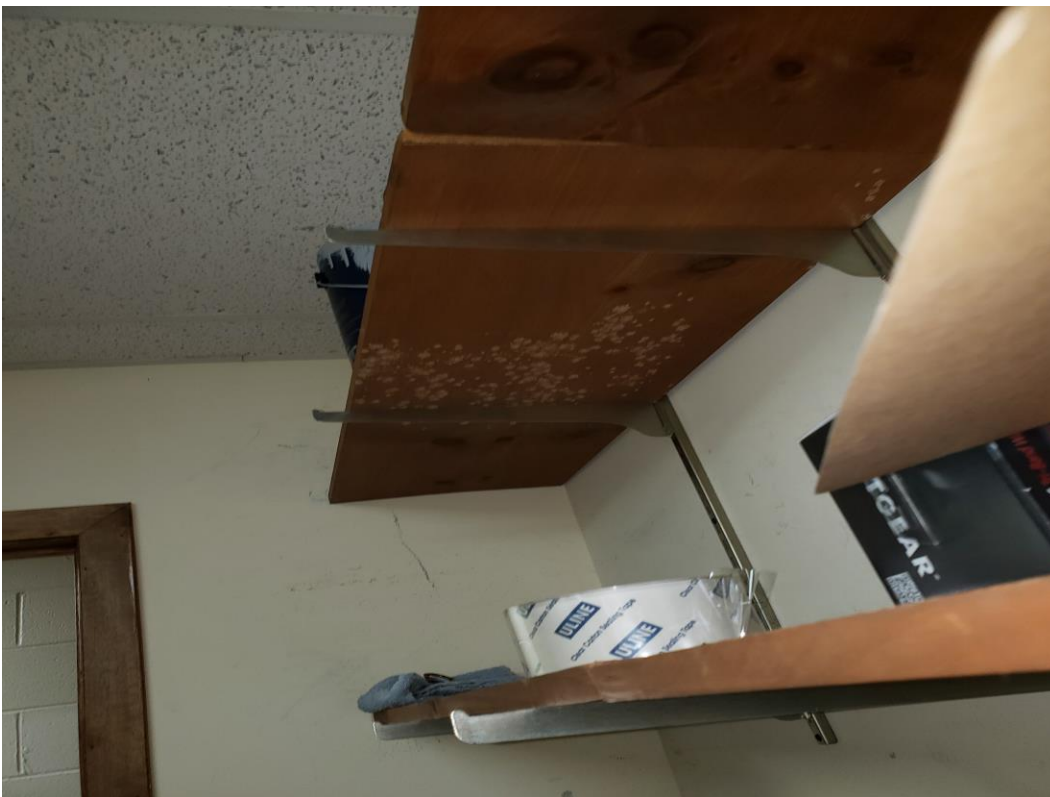
Photo 6: Location: Main Level – Office  
Item: Visible microbial growth on wood shelving unit likely caused by condensation.

- Remove and dispose of all porous building materials showing signs of visible water staining, elevated surface moisture content and/or surface mold growth. This would include, but may not be limited to: drywall, paneling, fiberglass insulation, shelving and ceiling tiles. Continue to remove the affected building materials a minimum of twelve inches past the last visible signs of microbial growth. Remove any visible dust or debris from throughout the rooms utilizing a HEPA vacuum. Any remaining affected wood, concrete, concrete block or other porous materials in the immediate area, which are not being removed, should be cleaned with a HEPA vacuum and/or an approved fungicide. When building materials are completely dry they should then be treated with a mold inhibiting encapsulant/sealer to discourage future mold growth.

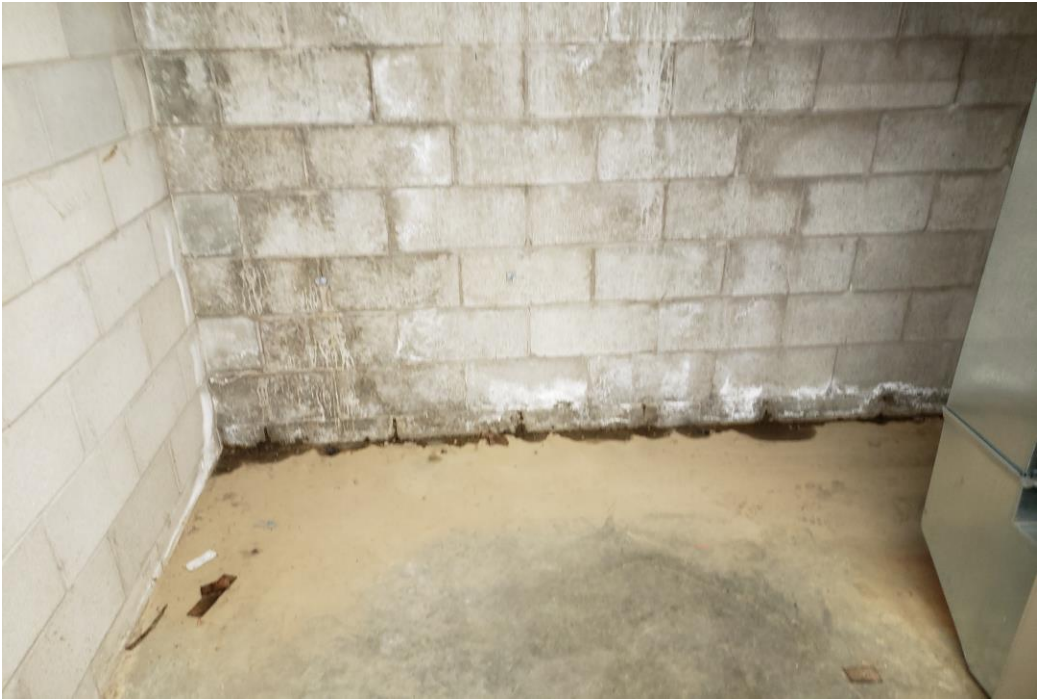
Photo 8:        Location: Basement – Exterior Wall  
Item: Water intrusion through concrete block wall.

- Professional duct cleaning, sanitizing, and replacement of the HVAC filters is recommended at the completion of remediation.
- Consider consultation with a contractor about any humidity or water intrusion issues that may be contributing to microbial growth in the basement (possibly adding gutters, fixing any grading issues, adding additional airflow or dehumidification, etc).

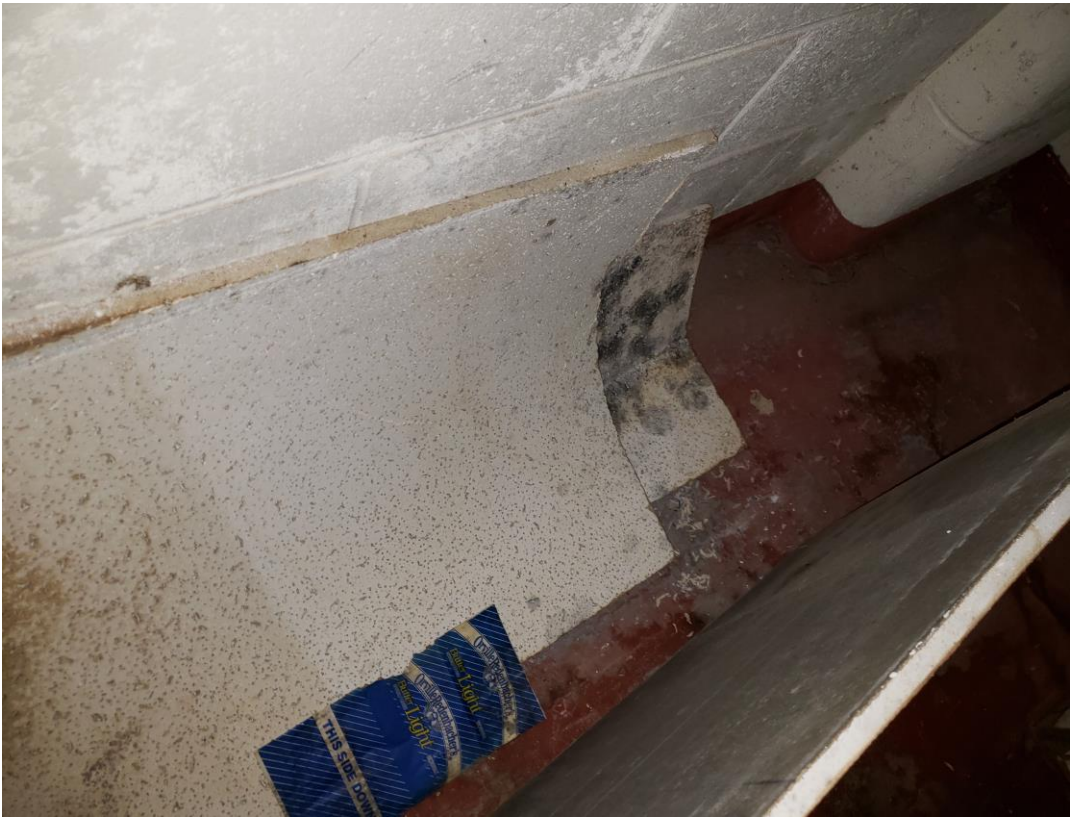
Photo 9:        Location: Basement  
 Item: Visible microbial growth on extra ceiling tiles.

- Remove and dispose of all porous building materials showing signs of visible water staining, elevated surface moisture content and/or surface mold growth. This would include, but may not be limited to: drywall, paneling, fiberglass insulation, shelving and ceiling tiles. Continue to remove the affected building materials a minimum of twelve inches past the last visible signs of microbial growth. Remove any visible dust or debris from throughout the rooms utilizing a HEPA vacuum. Any remaining affected wood, concrete, concrete block or other porous materials in the immediate area, which are not being removed, should be cleaned with a HEPA vacuum and/or an approved fungicide. When building materials are completely dry they should then be treated with a mold inhibiting encapsulant/sealer to discourage future mold growth.

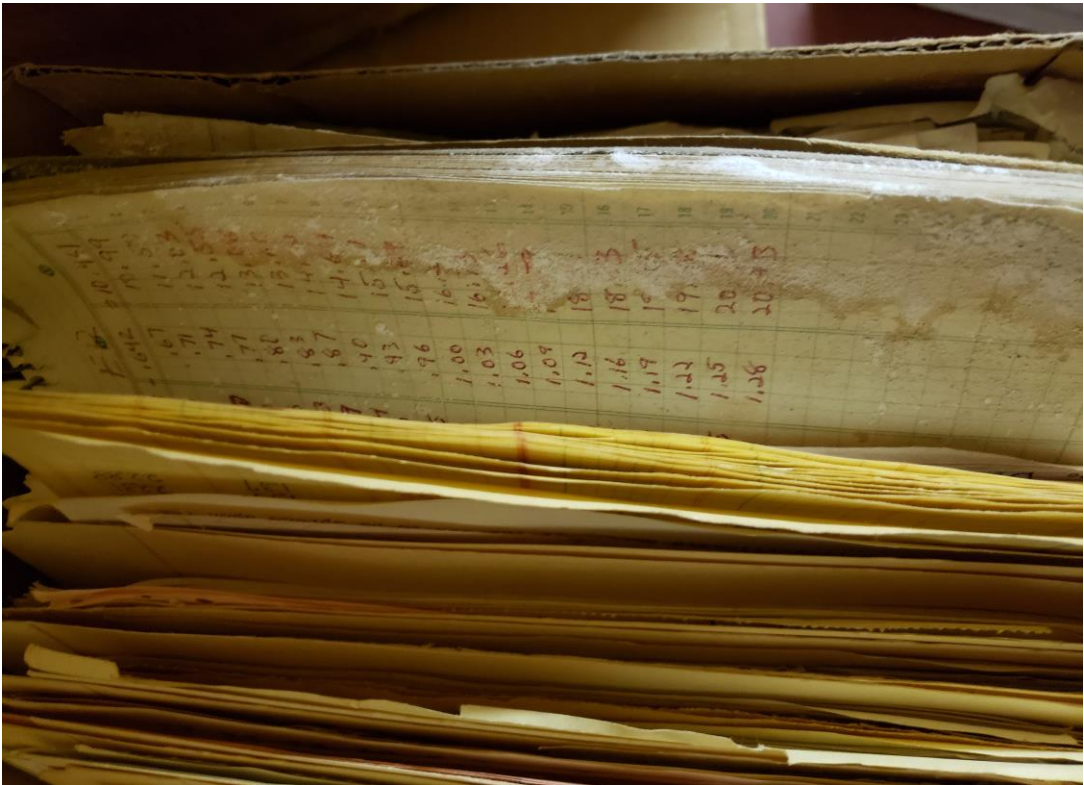
Photo 10:        Location: Basement  
 Item: Microbial growth on paper records.

- Remove and dispose of all porous items and contents within the affected area that cannot be properly cleaned (books, furniture, etc.). Items that are deemed salvageable should be properly cleaned with a HEPA vacuum and/or an approved fungicide.

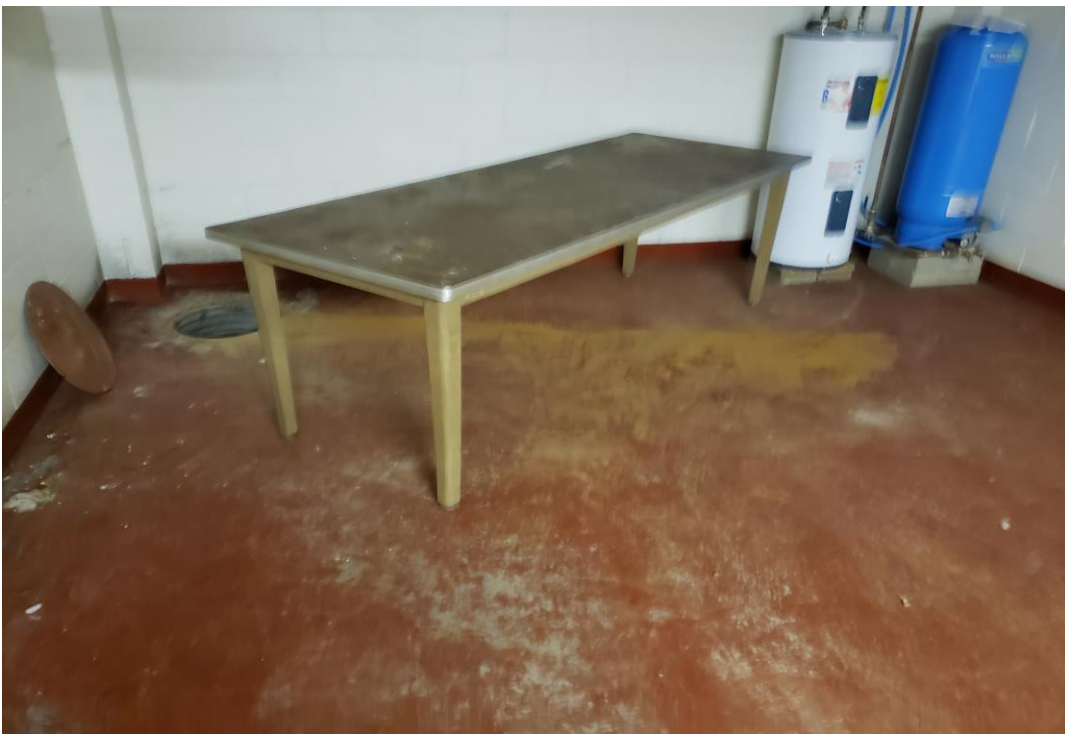
Photo 12:      Location: Basement  
Item: Water staining on concrete floor from water intrusions.
