# Town of Newbold Facilities Analysis Study Report

## Town of Newbold – Building Committee Town of Newbold, Wisconsin

11/05/19 Draft, 11/06/19 Revised,  
7/14/20 Final

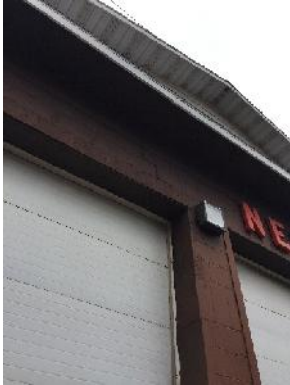
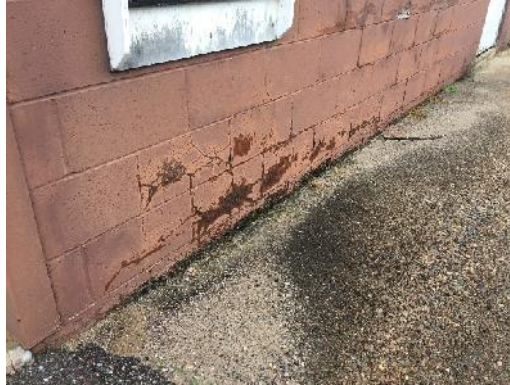
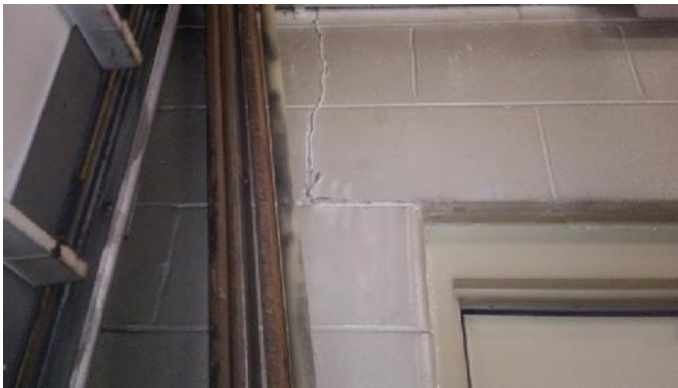
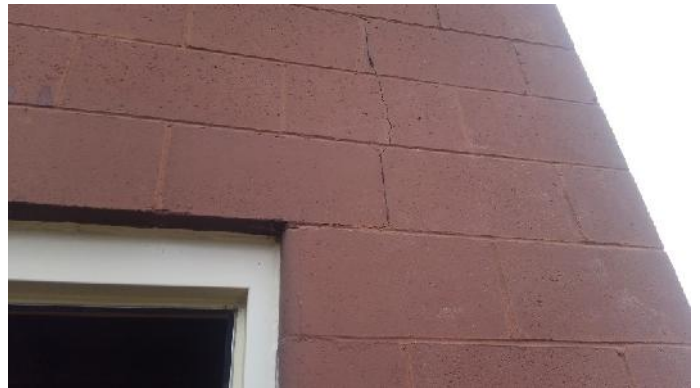
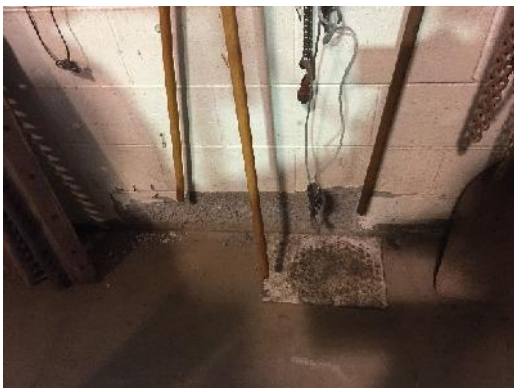
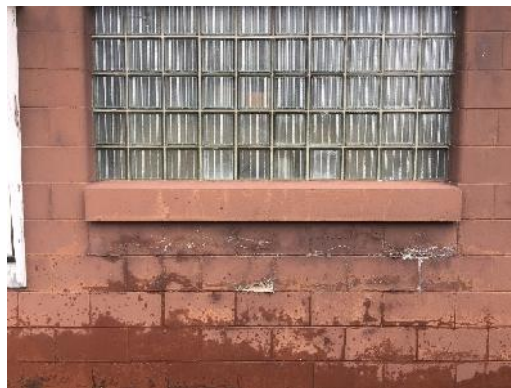
Exterior block wall has several areas of deterioration starting with some minor cracking where moisture has penetrated the walls system and freezing, and thawing cycles have caused some spalling and mold buildup. The interior side of the shop exterior walls also have issues of spalling, additionally due to the salt from the environment brought into the facility by the equipment. All the control joints and sealant joints have failed within the exterior wall, allowing moisture to penetrate the wall cavity and interior of the structure. The injected insulation within the exterior wall cavity is questionable regarding the energy performance, it is likely the insulation is only present within a few feet of the area of injection and that the entire wall is still lacking and insulation. (Photo S) The walls are in fair condition. (Photo A-F)

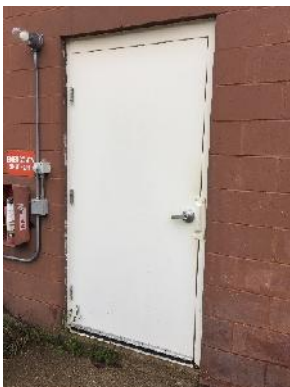
K

Exterior service doors are in poor shape, the frames are rusted through. (Photo K, J, L, M) Overhead doors are insulated with vision glass and motorized openers are in good condition, the exterior weather stripping has failed. (Photo N) Slab at the overhead doors has areas of edge spalling, where the overhead door has no sealing capabilities to the slab. (Photo O). Window units are inset into glass block with single glazed operable units. (Photo P, Q) Many openings have been blocked by furnishings allowing for no access. The units are in poor to failed condition. Interior wood doors are in fair condition.

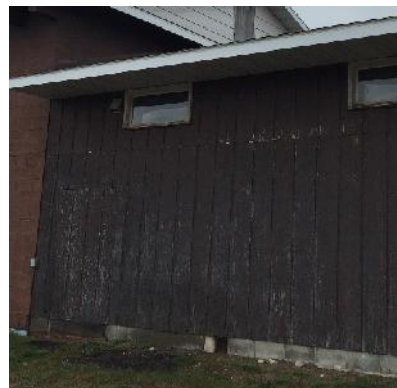
U

Exterior wall is exposed gypsum wall board that was never finished. There have been many areas repaired due to failure, most likely damaged by equipment stored along the exterior walls. (Photo X) The exterior wall wood panels have failing at the bottom of the panels adjacent to the concrete sill block curb due to moisture. The exterior wood panels and trim are in poor condition. (Photo U, Y, Z)

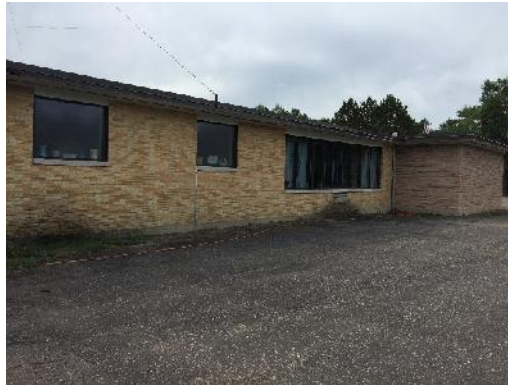
B

The building is in good to fair condition and structurally sound with minor exterior wall cracks and water infiltration. (Photo A, B) The current structural roof system appears adequate. The current IBC 2015 Snow Load is 42 psf plus dead load, (borderline OK), the IBC code is not retroactive, and as such, the roof is considered fully functional and compliant with current code. No damage was observed in the roof that would indicate historical over loading or a current hazard to occupants, so it can be left "as is". (Photo C, D) The gymnasium exposed glulam beams on the exterior are deteriorating due to the exterior environment, the exterior sections of the beams are in poor condition. (Photo E, F)

**External Walls:** Tuck point all exterior and interior cracked walls, cut new control joint in the first two west classrooms, remove all wood window boxes and repair any damaged brick. Reseal all control joints and material transitions with new sealants. Clean the existing brick to be free of mold. Install new weep holes in the existing exterior walls.

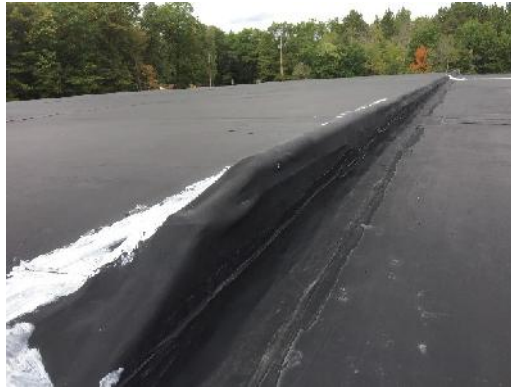
H

The roof membrane is in fair-poor condition, the owner noted that he patches the roof when leaks appear. Based on the exterior fascia trim the roof has additional rigid insulation added, exact amount is unknown. The roof should have core samples taken to determine the exact roofing materials and insulation depth. (Photo G, H, J)

**Roof:** Replace the existing roof, insulation and fascia. Repair all wood soffits. Review all flashings for any potential installation issues. Cut back the exposed rotted glulam beams at the gymnasium and clad the exposed glulams.

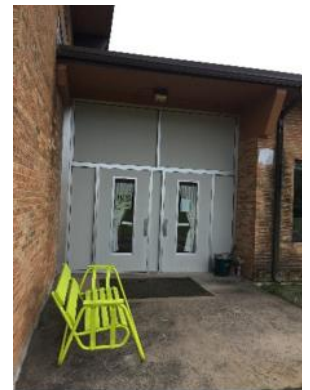
K

Exterior service doors are in good shape. (Photo K) Window units are in good condition. (Photo L, M)

**Openings:** Reseal all exterior joints at perimeter of windows and doors. Repaint hollow metal door and door frames. Replace all non-compliant hardware.

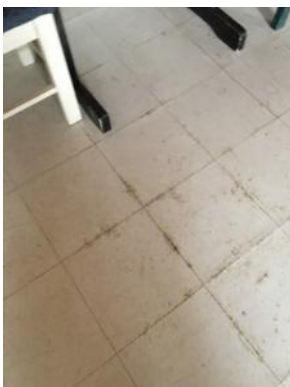
S

Interior 12x12 glue applied tiles are in fair condition, the tiles are stained from roof leaks and show signs of sagging. (Photo Q, R) All interior carpet and vinyl tile is in poor condition. The vinyl tile and mastic (defined asbestos material) must be abated prior to any construction. (Photo S, T) Ceramic tile floor is in fair condition. Ceramic wall tile is in poor condition due to the alterations from the original design into a private residence. Wood doors, frames and trim are in fair condition, with scratches and veneer delamination. (Photo U, W, V) All interior concrete block walls are in good condition. Interior toilet room partitions are in poor condition as should be reconfigured. (Photo X-AA)
